# Acute epileptic electricity supply in Isoko North Local Government Area of Delta State: Its causes and remediation

Obukoeroro John<sup>1\*</sup> and Uguru, H. E.<sup>2</sup>

**ABSTRACT:** Epileptic electric power supply had become a common factor in Isoko North Local Government Area of Delta State, Nigeria. This study looks at the immediate causes of the prolong power failure in the area, in order to proffer solutions to them. Field work and questionnaires were used to obtain data for this study. During the field work, the main 33 KVA Isoko-Kwale transmission line was thoroughly inspected to ascertain its current state. In addition, the primary (11 KVA) and secondary (415 V) distribution lines, the transformer and feeder pillars were also inspected. Furthermore, questionnaires were distributed to three categories of people (electricians, civil servants and traders), to ascertain the remote causes of epileptic power supply in the region. Results obtained from the field work revealed that some of the electrical materials used in the 33 kVA transmission line were in bad shape. There were instances of missing cross arms from the utility poles, and the insulators were fixed directly

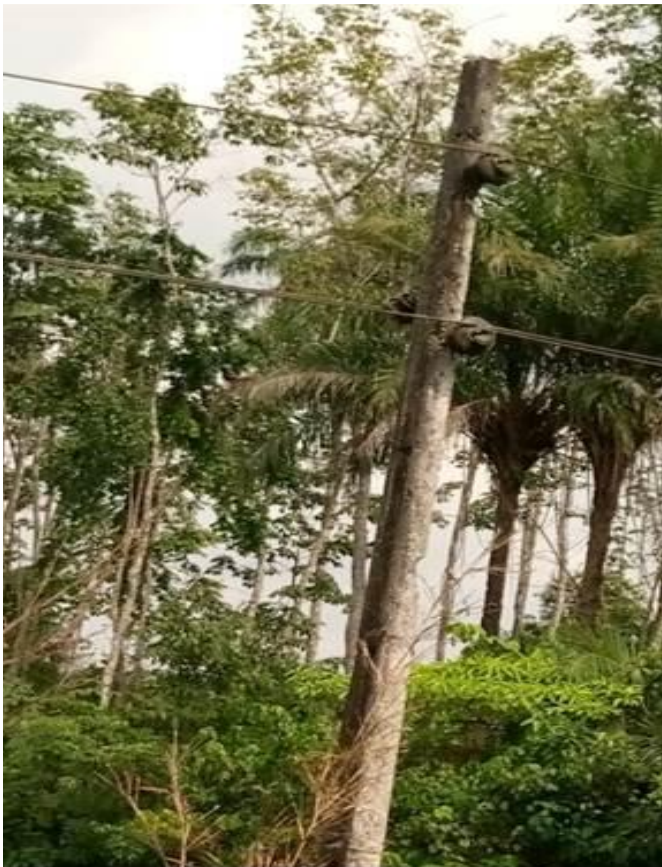
**Figure 2.** Insulator attached directly to the utility pole at Oleh Community.

### State of the 33 KVA Isoko-Kwale transmission line

1. Overhauling of the entire 33 KVA and distribution lines. Some sections distribution lines are obsolete when compared to the NIS recommendations. The overhauling should be done in accordance to the

NERC and NIS recommendations. This will help to minimize the rate at which electromechanical faults occurred along the lines. Hence, power outages will be minimized, since a lot of the power failures experienced in the area are due to electromechanical faults.

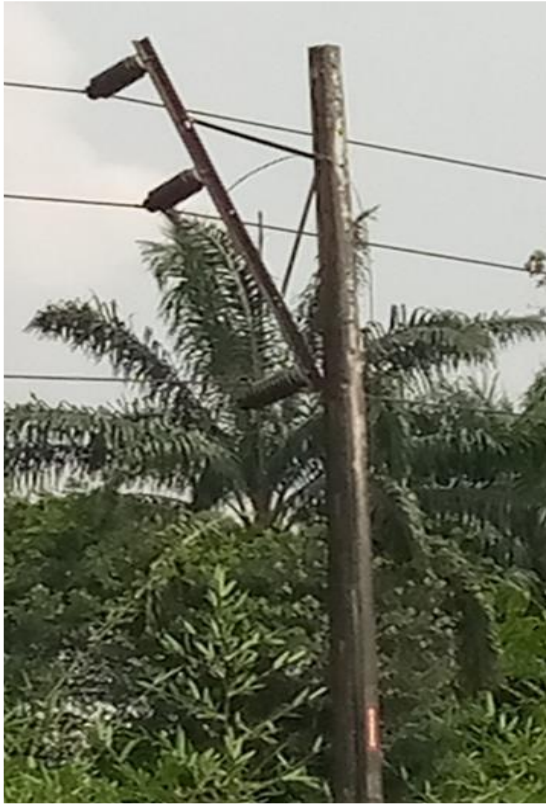
**Figure 3.** Hanging cross arm at Emede Community.

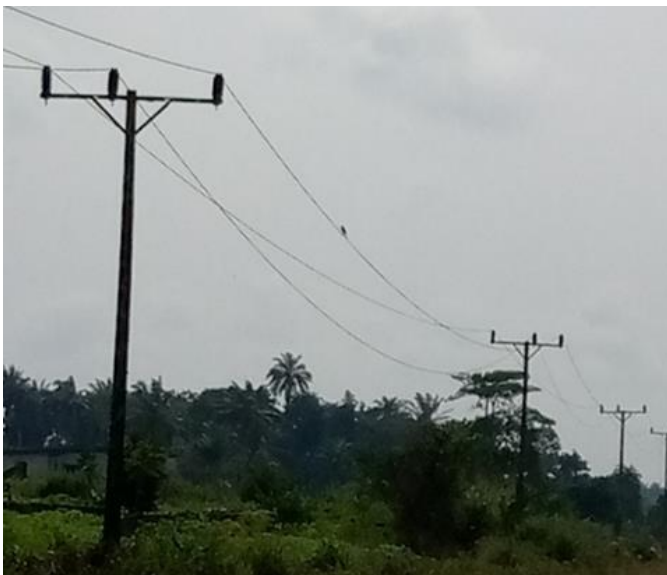
**Figure 4.** Sagging transmission cables Between Oleh and Ozoro community.

Additionally, extremely sagging of the transmission line was notice at various points (Figure 4). The sagging was very obvious in the forest regions, where the transmission line passes through. These conditions are against the standard practice of electrical installation and safety standards. Although, the tension in the cable should not be too high, as the cable can snap under high voltage; but excessive sagging of the cable can lead to electrical problems. According to Oluwajobi et al. (2012), excessive sagging of transmission cable is liable for causing power failure. High voltage sagging transmission cables can touch trees during windy condition, hence, creating electrical sparks which usually leads to power failure. Additionally, Liquidators (2020) stated that extreme sagging of transmission cable is hazardous; if it falls below the recommended height, the cable will come with contact with trees, buildings and other structures beneath it; therefore, causing electrical fire and electrocution.

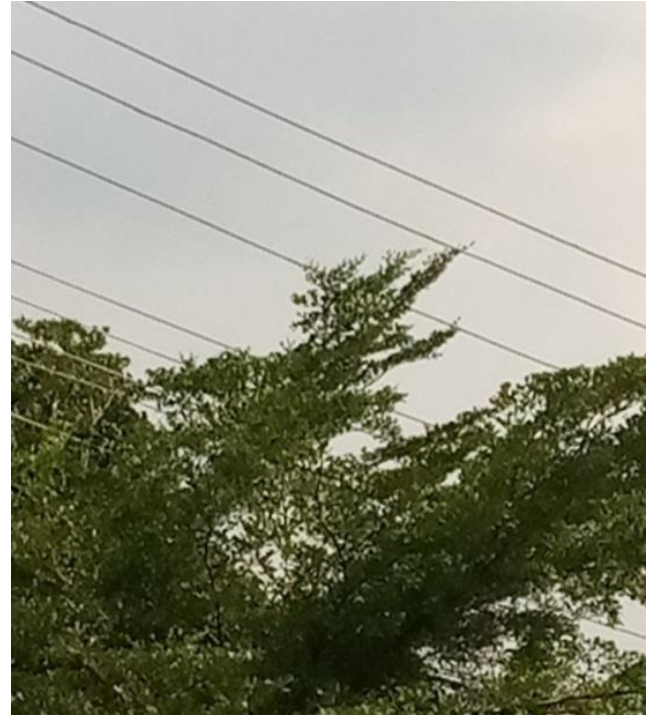
**Figure 5.** Secondary distribution line overgrown with trees.

During the field work, it was notice that some of the primary and secondary distribution lines were not hitch free. Slanting utility poles and cables overgrown with trees were observed in the field (Figures 5 and 6). As seen in (Figure 5), the secondary distribution lines were covered with tree branches. This is unsafe for both the residents of the area and the power transmission system. The tendency of the cables been bridged during light breeze or rain is higher, since wet materials (wood) are good conductor of

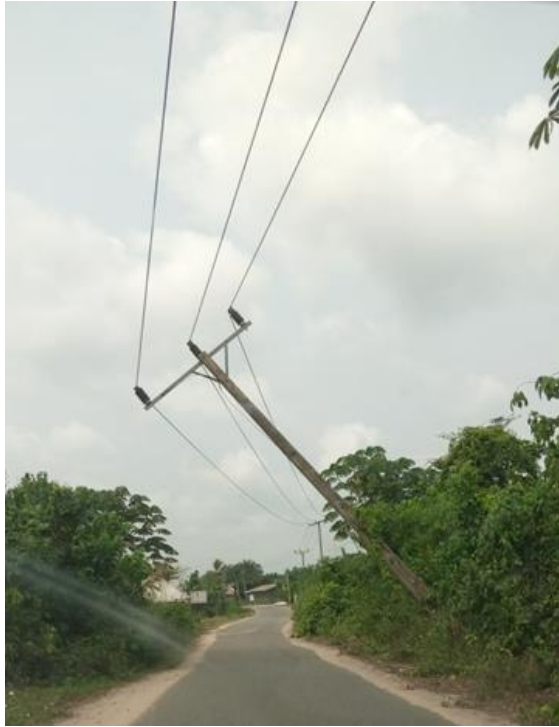
**Figure 6.** A slanting utility pole at Owhe community.

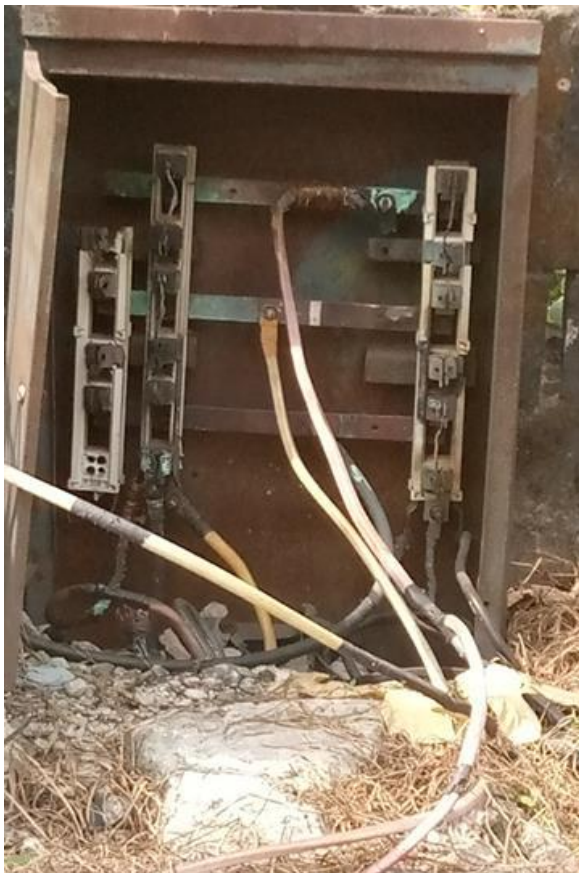
**Figure 7.** A transformer feeder pillar.

The field survey revealed that most of the power transformers were in bad conditions and unable to operate at the rated capacity. Incidence of built amour cables and feeder pillars were high in most of the transformers visited (Figure 7). Standard NIS rating fuses were missing in almost all the feeder pillar visited, as the feeder pillars were fused with copper wires of unknown rating. The implication of this unethical act is that, any fault in the secondary (415 V) distribution line can bypass the feeder pillar (if a higher rating fuse wire is used) and affect either the transformer or the primary (11 KVA) distribution line. This can cause major power outage that can takes weeks or months to rectify. Information obtained from the BEDC staff revealed that in case they fused the feeder pillar with very low rating wire to safeguard the transformer and transmission line for overloading or other electrical faults, this act can lead to consistent electric power tripping off, which will affect the consumers of the 415 V transmission lines. According to NERC and NIS recommendations, transformers fuses must be installed in accordance with manufacturer's specifications (NERC, 2014).
