Road vulnerability and the dynamics of rainfall along Igbara-Oke road, Ondo State, Southwestern Nigeria

ABSTRACT: This research showed the significance of rainfall, Very Low Frequency Electromagnetic (VLF-EM) and electrical resistivity method for road vulnerability along Igbara Oke road, Ondo State, Nigeria. In doing this, a geophysical approach has been adopted with the use of two geophysical methods involving Very Low Frequency Electromagnetic (VLF-EM) and electrical resistivity method using Lateral Resistivity Profiling (LRP) and Vertical Electrical Sounding techniques (VES) for a distance of more than half a kilometer. The lateral resistivity profiling allowed for evaluation of lateral variation in resistivity with respect to a fixed depth while the vertical electrical sounding for the understanding of the layer stratification of the study area in term of thickness and layer resistivity. VLF-EM was engaged to define the study area with respect to conductive and resistivity zone, while the methodological data of rainfall pattern within the last ten years was engaged to understand the dynamics of rainfall within this period. The Wenner profiling has a resistivity distribution/va

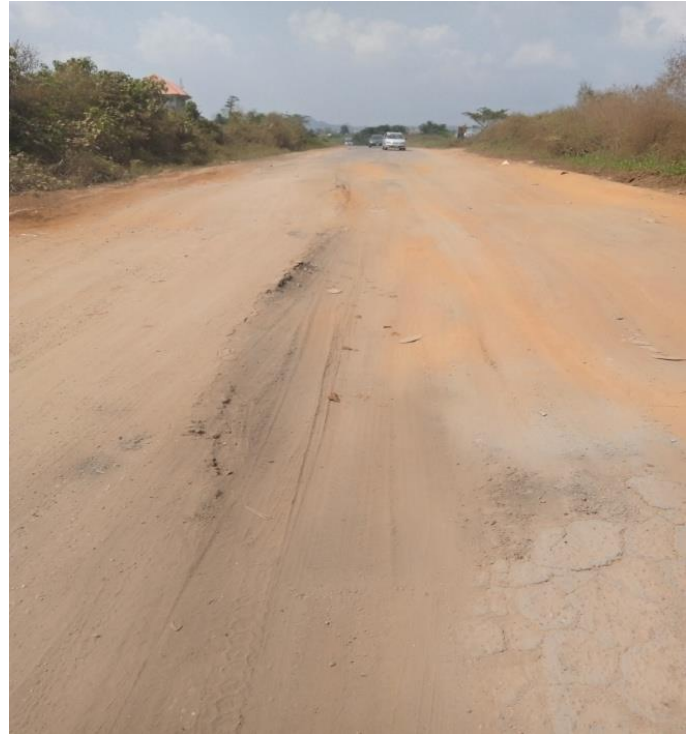
Plate 1. Failed Segment at location 1 before its recent reconstruction/rehabilitation.

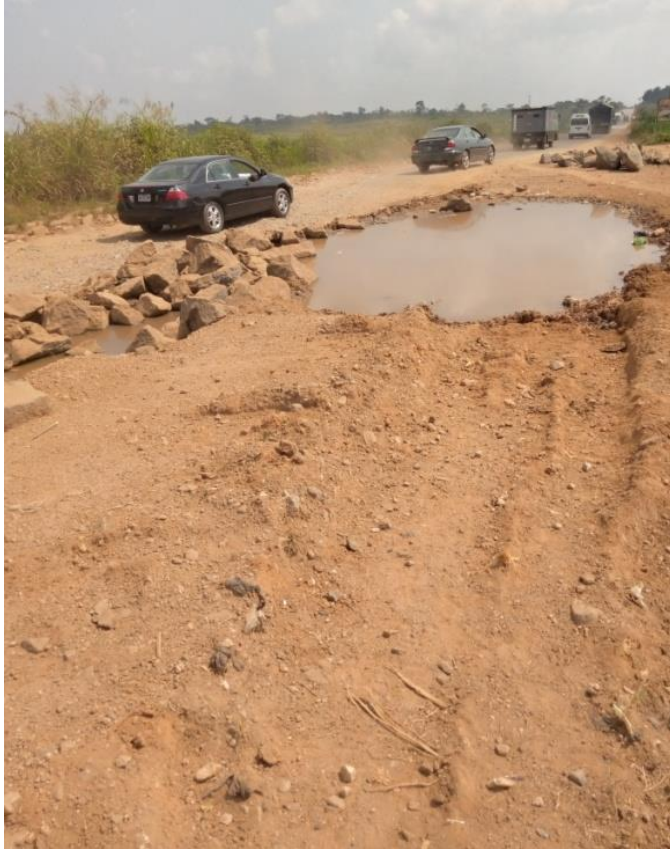
Plate 2. Failed Segment at location 2 before its recent reconstruction/rehabilitation.

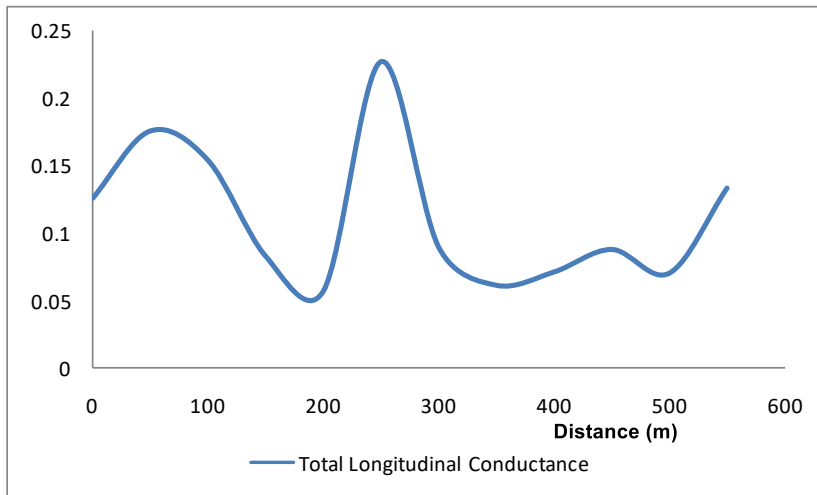
Figure 7. Total longitudinal conductance along the investigated road.

Results obtained from the VES interpretations were used to determine the second order parameters. Total longitudinal conductance (Figure 7) was generated from the second order parameters which reflect the inherent weakness of the subsurface geologic materials, especially between 5 to 130 m, 210 to 290 m and 420 to 530 m. Its

constitute about 60% and majorly account for the reason why the soil integrity and the superficial geological material that constitute the founding materials are of doubtful integrity, aiding vulnerability to failure, coupled within the sudden rise in rainfall pattern and seasonal variations in global weather condition over the years, resulting in esteem temperature condition during dry season and unprecedented increase in rainfall pattern during the

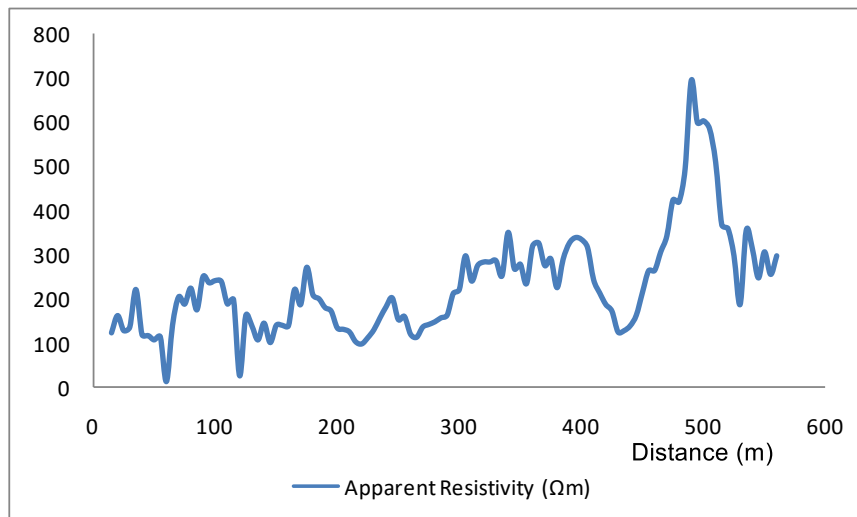
Figure 8. Horizontal profiling of the study area.

Figure 8 exhibit plot of apparent resistivity against station position using wenner array configuration where electrode

movement was 5 m and inter-electrode spacing of 10 m. This profile covers a distance of 600 m for better understanding of lateral variation in resistivity which gave a fair representation of the structural features and physical parameters. The resistivity distribution at 0.0 m could be

described as moderately low and very low with the worst areas been located at distance between 20 to 60 m, 120 to 160 m, 200 to 240 m, 260 to 280 m and 420 to 460 m; the resistivity varies between 20 to 100 Ωm which was almost 30% in terms of materials distribution (Table 1).

Furthermore, the moderately low regions are located between zero to 30 m, 80 to 120 m, 170 to 190 m, 300 to 410 m; with resistivity ranging between 150 to 250 Ωm , and this account for about 33.3% of the material distributions in the study area. While the rest of the materials distribution has apparent resistivity values range from 255 to 750 Ωm and percentage rate of resistivity distribution (Figure 9). Therefore, the combined effect of very low resistivity materials when combined with moderately low resistivity material has an overwhelming and over siding effect on the high resistivity materials within study area. Along with the seasonal variations and the gradual global weather changes responsible for the sudden changes in rainfall pattern within the last few years (Figure 3), may be majorly accountable for the apparently vulnerability of the road to incessant failures that has brought about its rehabilitation for three times within the last ten years. The pattern also reflects the general nature of the materials within the study area when viewed against the background of its conductivity. The percentage rating for failure index (A) and stability index (B) was calculated

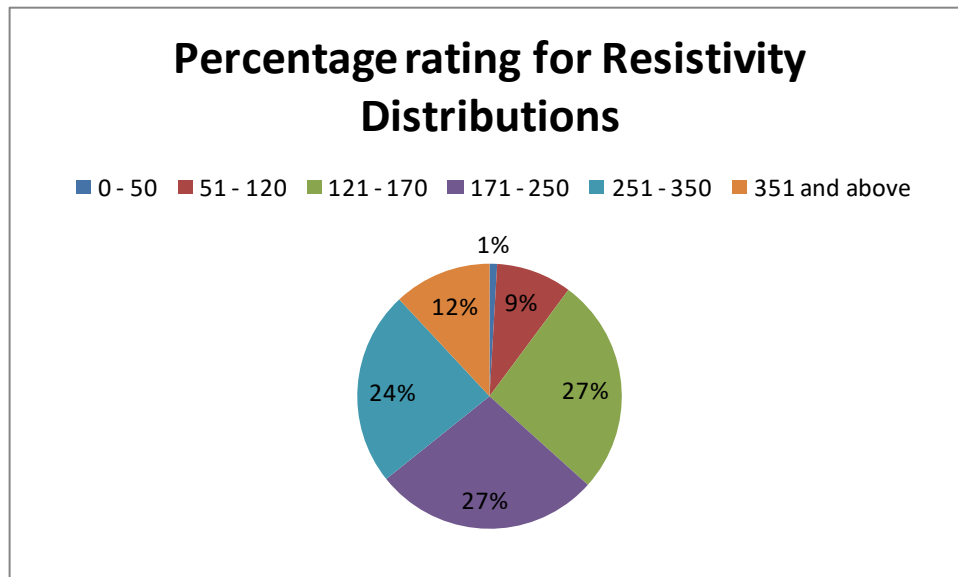
**Figure 9.** Percentage rating for resistivity distribution of the study area.

to get the vulnerability factor of 1.54 (Table 2). Therefore, for any road to be stable, vulnerability or stability factor A/B must be less than or equal to one (≤ 1). The conductivity profile (Figure 10) clearly demonstrate that the study area is generally conductive, reflecting on the weak nature of the near surface material apparently occurring throughout the study area.

However, vulnerability factor = $A/B = 60.62/39.40 = 1.54\%$

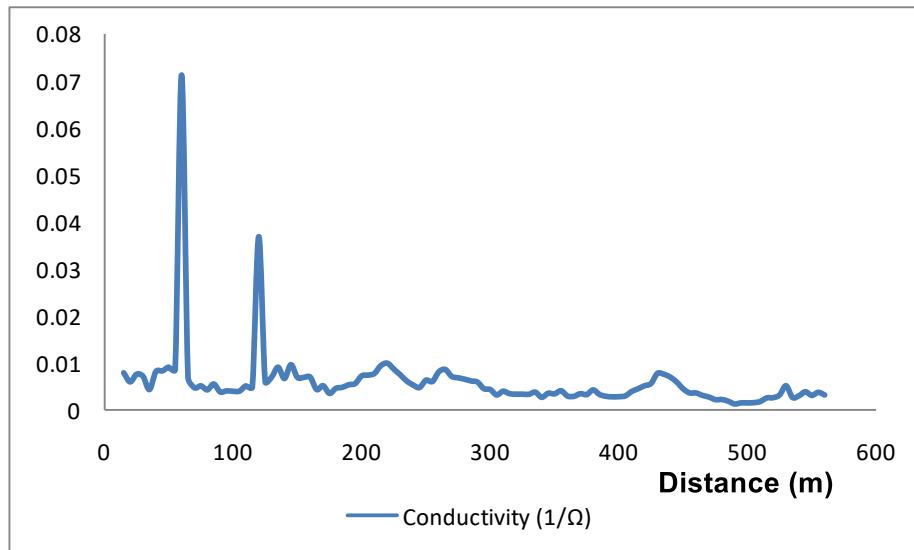
Figure 10. Conductivity profile of the study area.

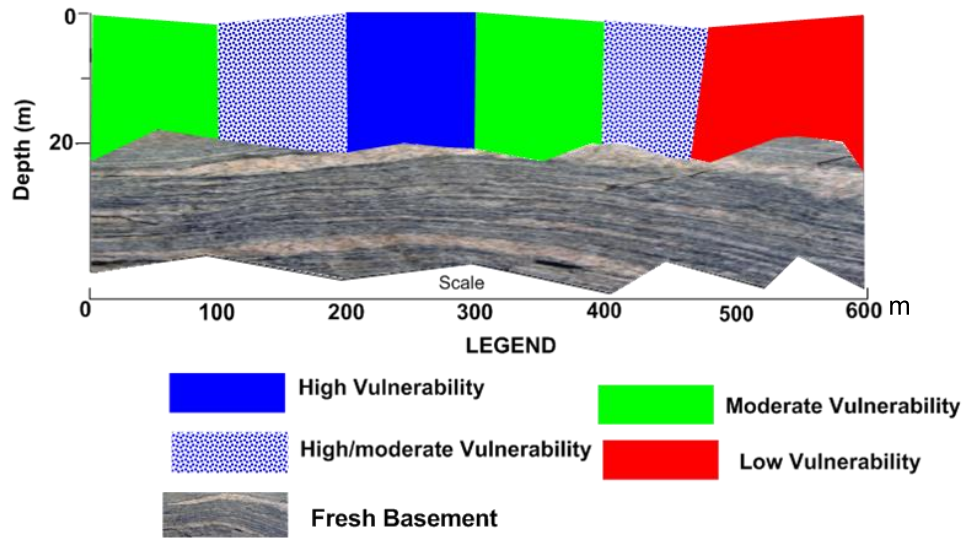
Figure 14. Road vulnerability section for the investigated area.

Vertical Electrical Sounding (VES) results. The integrated results of geophysical investigations have enabled the development of the road failure vulnerability section of the studied road. The road segments are categorized into four zones of vulnerability to failure. These zones are high, high/moderate, moderate and low vulnerability zones (Figure 14). It is estimated that about 35% of the road segments is rated to be of high/moderate vulnerability and 35 % of the section has moderate vulnerability. 15 % each of the segments are rated to be of high and low vulnerability.

within this investigated area due to high durability but the region for high, high/moderate and moderate vulnerability must be put into cognizance against the background of the clayey nature of the surface material, dynamic of rainfall pattern and variations resulting from ozone layer depletion and other associated geodynamics activities (Figure 15). Because clay is a natural material composed primarily of fine-grain minerals. It consists of tiny particles that have plastic and adhesive properties. It also possesses small voids and pores, so it is capable of retaining water. In this condition, it tends to expand and shrink, which can lead to settlement. When exposed to increments of water, clay tends to soften and liquefy. It also causes difficulties in construction with its low strength and stiffness. This has caused serious problems in road construction because weak soil may cause damage to the cracks along the road pavement (Bawallah et al., 2019b).
