# Socio-economic implication of Yedzeram river bank erosion and floodings on the livelihood of Southern Mubi Community Dwellers, Adamawa, Nigeria

**Appendix 1.** Locations and nature of devastation by **RBE and Flooding** in Southern Mubi

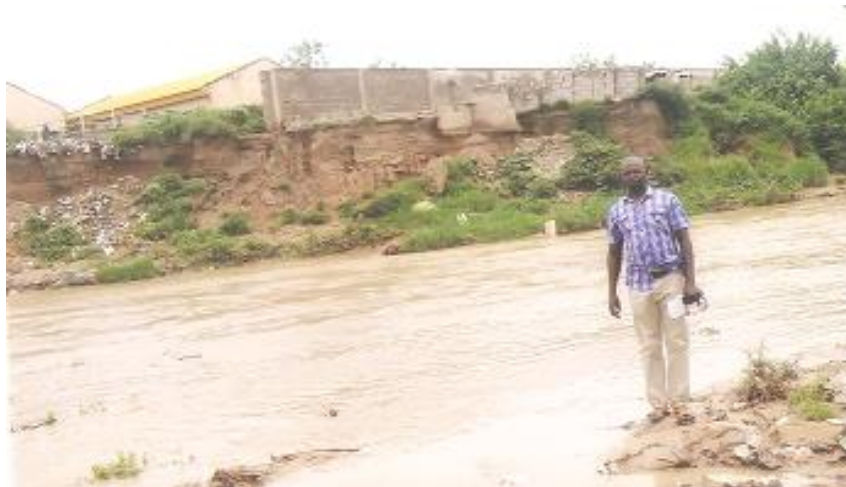
**Plate 2.** Mass wasting adjacent a construction company.

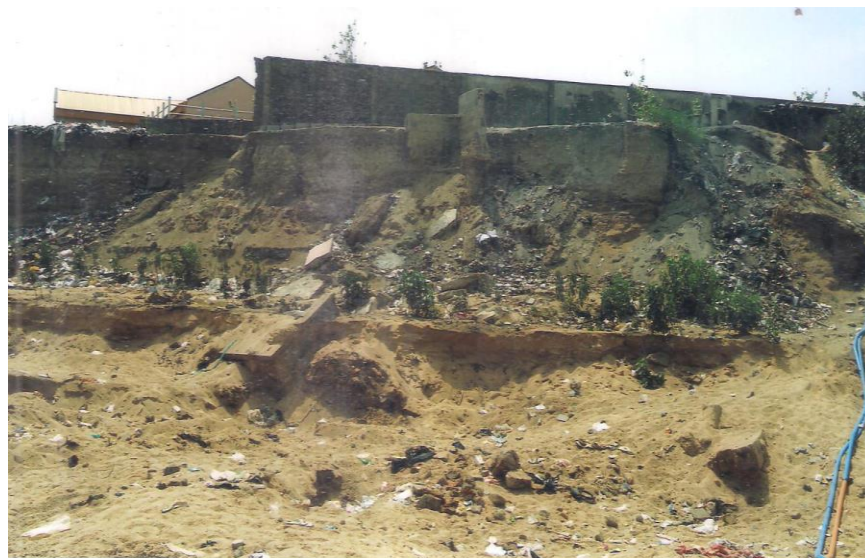
**Plate 3.** Foundation under threat along the riverbank of Yedzeram.

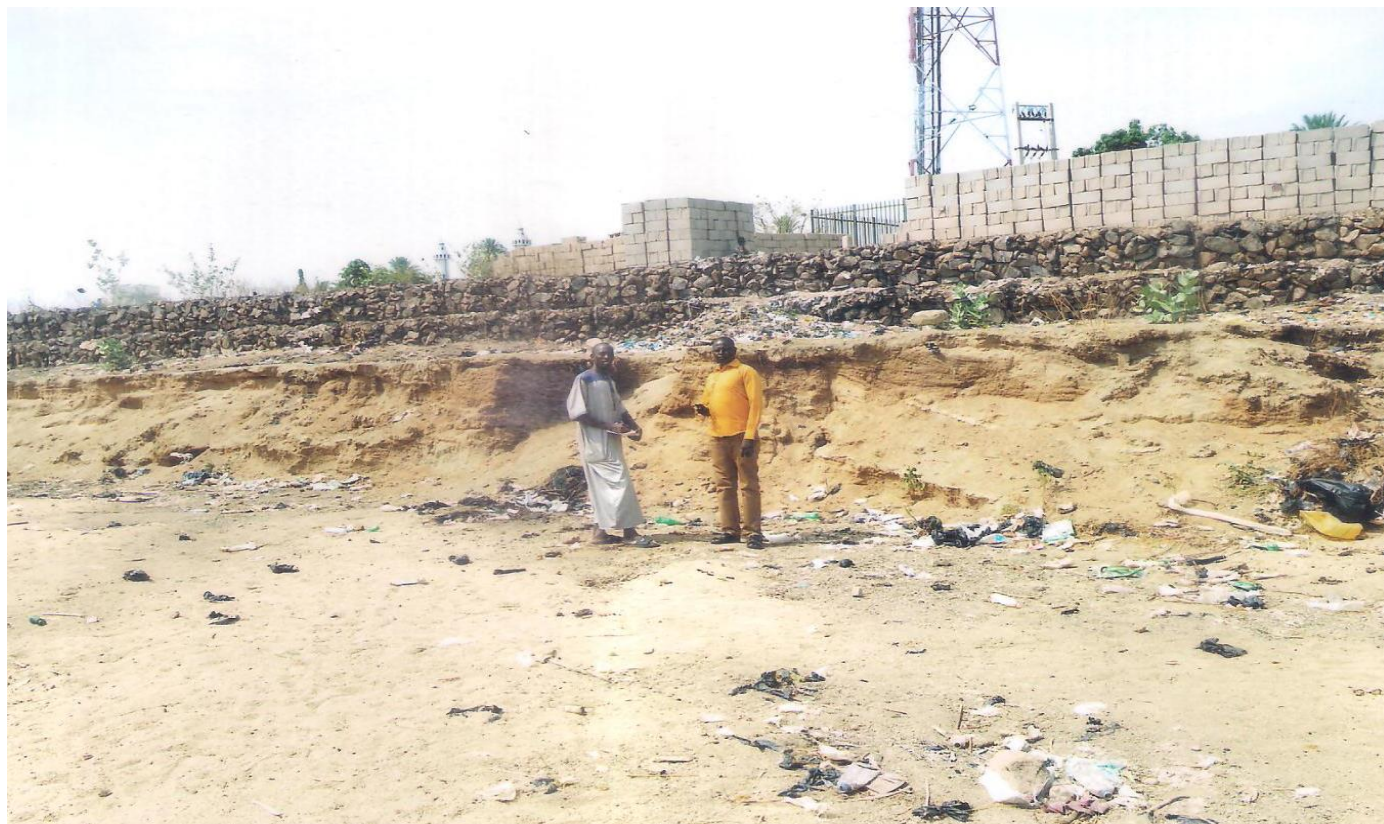
**Plate 4.** Block industry along the study riverbank-sand mining.

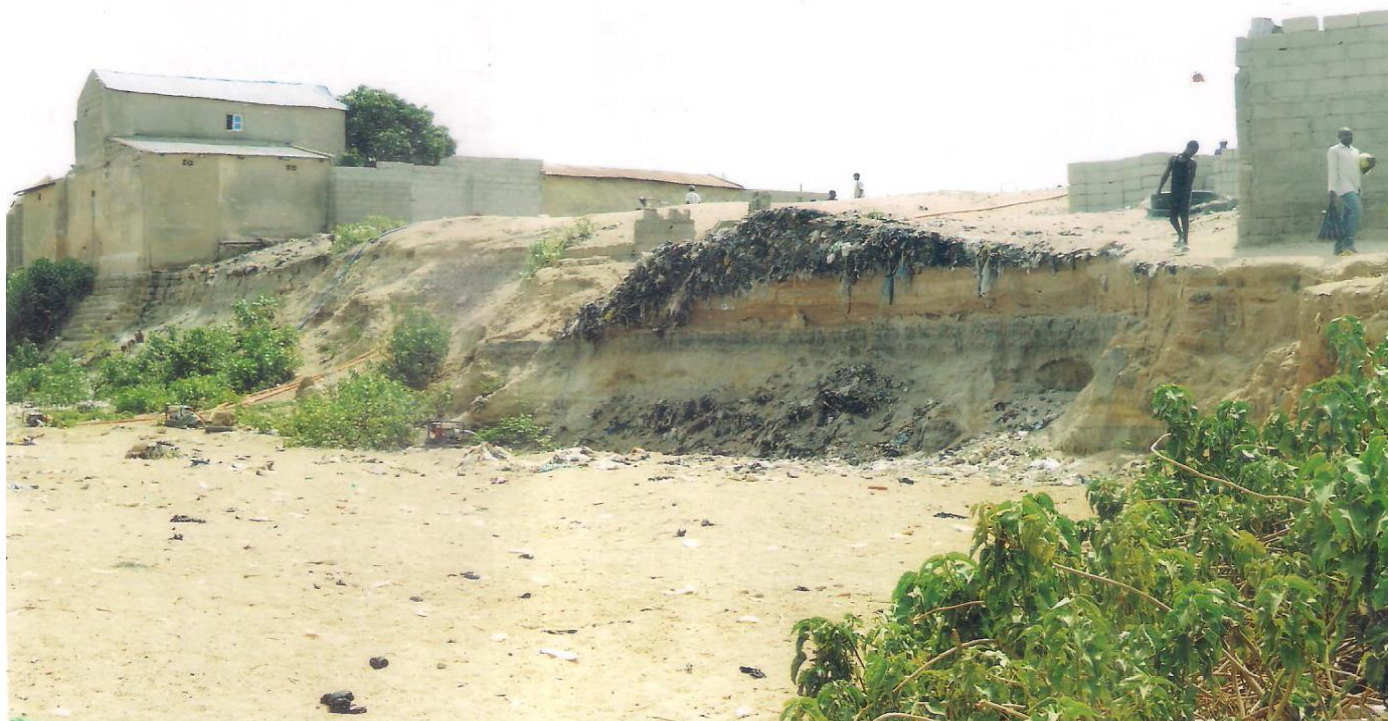
**Plate 5.** Encroachment along river Yedzeram.

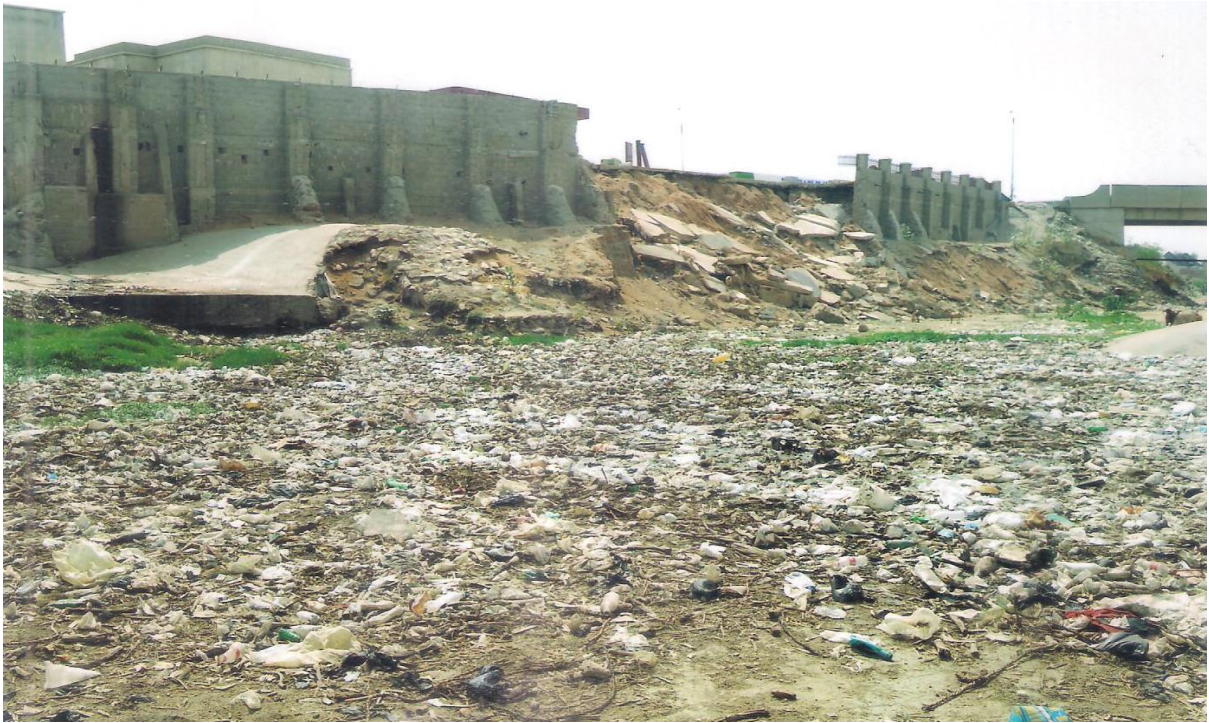
**Plate 6.** Dilapidated embankment along the riverbank.
