# Acute epileptic electricity supply in Isoko North Local Government Area of Delta State: Its causes and remediation

Obukoeroro John<sup>1\*</sup> and Uguru, H. E.<sup>2</sup>

**ABSTRACT:** Epileptic electric power supply had become a common factor in Isoko North Local Government Area of Delta State, Nigeria. This study looks at the immediate causes of the prolong power failure in the area, in order to proffer solutions to them. Field work and questionnaires were used to obtain data for this study. During the field work, the main 33 KVA Isoko-Kwale transmission line was thoroughly inspected to ascertain its current state. In addition, the primary (11 KVA) and secondary (415 V) distribution lines, the transformer and feeder pillars were also inspected. Furthermore, questionnaires were distributed to three categories of people (electricians, civil servants and traders), to ascertain the remote causes of epileptic power supply in the region. Results obtained from the field work revealed that some of the electrical materials used in the 33 kVA transmission line were in bad shape. There were instances of missing cross arms from the utility poles, and the insulators were fixed directly

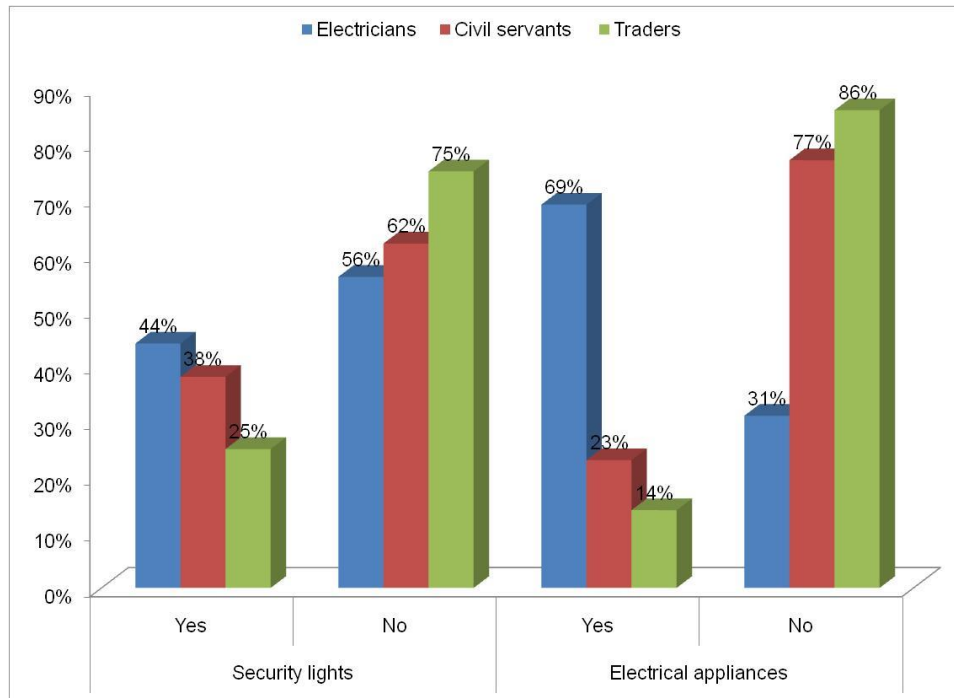
Results obtained from questionnaires and field survey revealed that most of the residents of the area abuse the electric power supplied to them. A greater proportion of them do not switch off their security (outside) lights during the day time (Figure 1). As seen in (Figure 1), 56% of the electricians, 62% of the civil servants and 75% of the traders did not switch off their security lights during the daytime. In addition, the respondents admitted (Figure 1) that they do not switch off their electrical appliances (e.g. freezers, inner electricity bulbs, ceiling fans, etc.) when leaving the house, despite the warnings of Nigeria Fire Service that this act can leads to overloading and electrical fire. It was only 69% of the electricians, 23% of the civil servants and 14% of the traders that switch off their electrical appliances when leaving the house; while the remaining respondents intentionally left their appliances on when leaving their houses. The respondents attributed their actions to the "high" estimated electricity bills given to them by BEDC. This unnecessary energy wastage could lead to overloading and tripping of the electric power at the power station. BEDC had stated many times that its 33 and 11 kV feeders are being overloaded; thereby leading to

**Figure 1.** Undue power consumption in Isoko North.
